47TH TURBOMACHINERY & 34TH PUMP SYMPOSIA
HOUSTON, TEXAS | SEPTEMBER 17-20, 2018
GEORGE R. BROWN CONVENTION CENTER

Case Study on investigation and resolution of Dry Gas Secondary Seal Failure

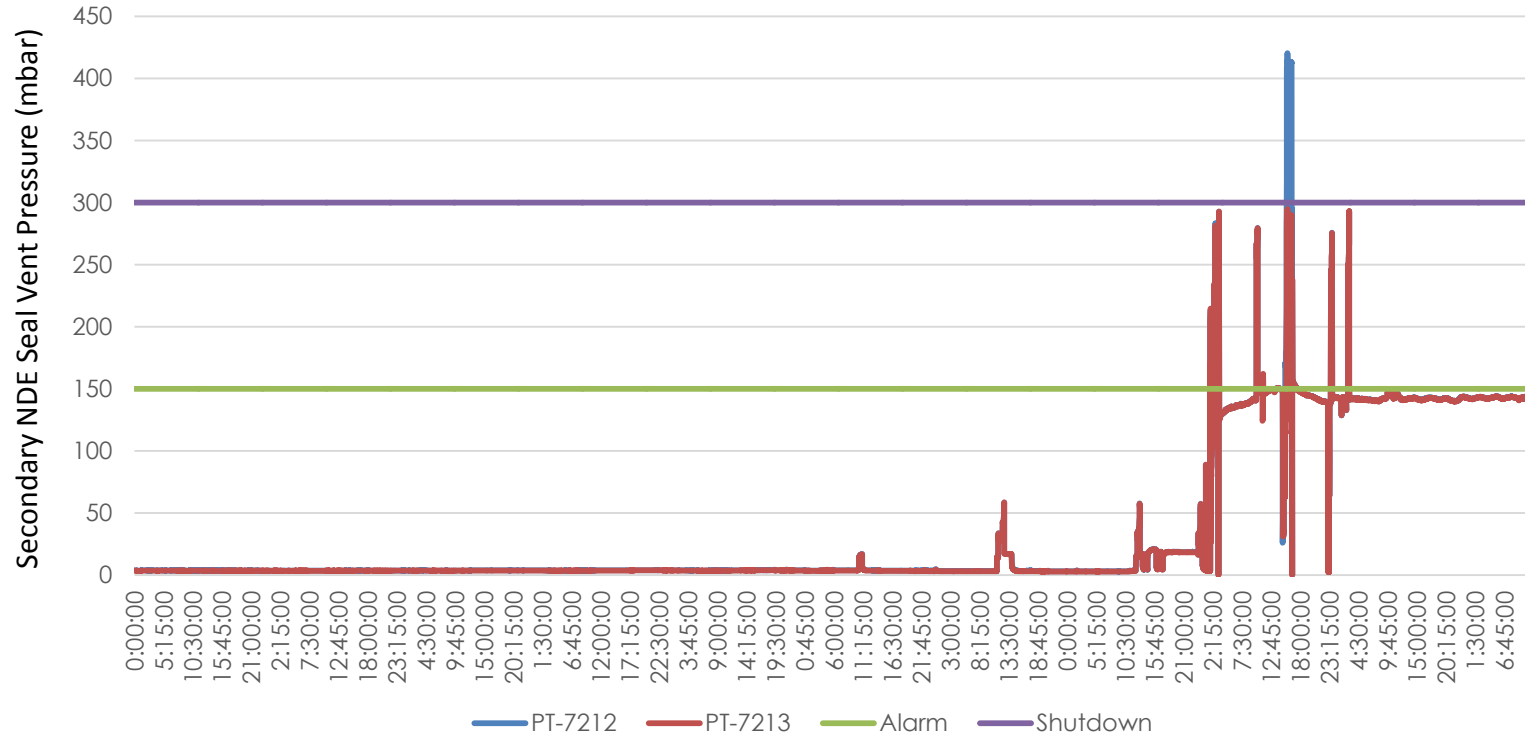
Historical Trending of NDE Seal Pressure Monitoring

Secondary seal
NDE vent
pressure
exceeded the
high-high limit
and compressor
tripped

Verified
historical data
trending from
DCS and
confirmed DGS
failure

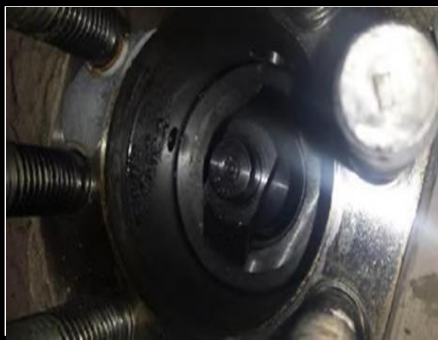
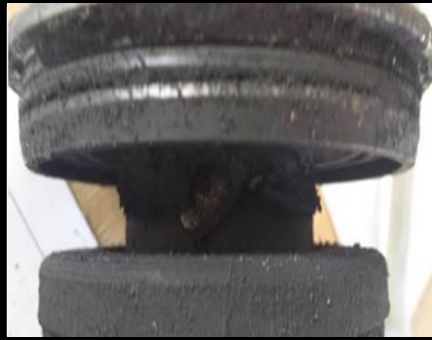
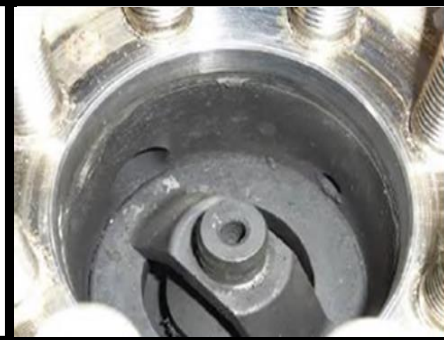
1. Carbon dirt / soot inside the Seal Gas Filter Casing.

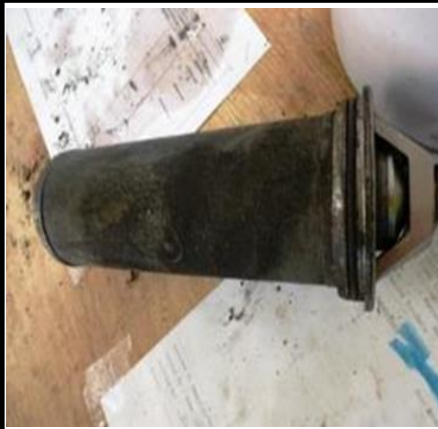
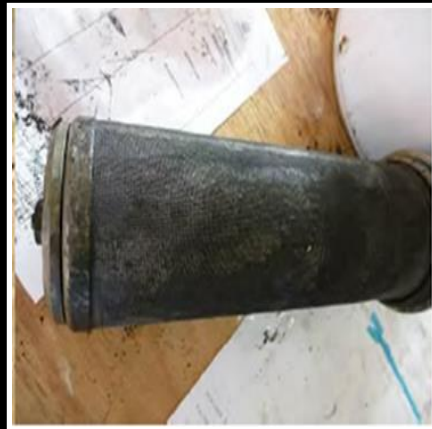
2. Dirty Seal Gas Coalescing Filter.

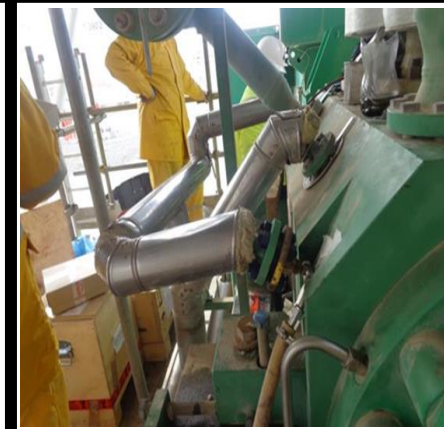
3. Contaminated Seal Gas Supply piping.

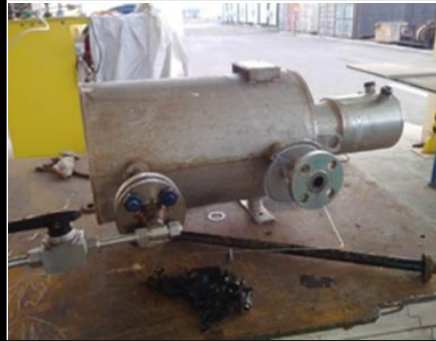
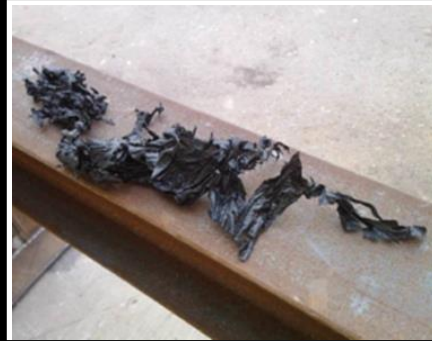
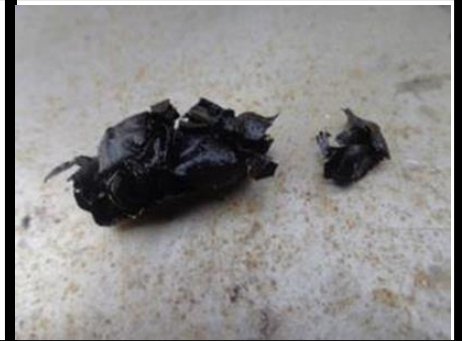
4.Foreign material inside the seal gas heater.

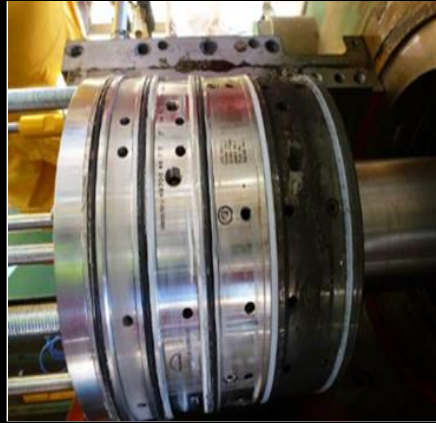
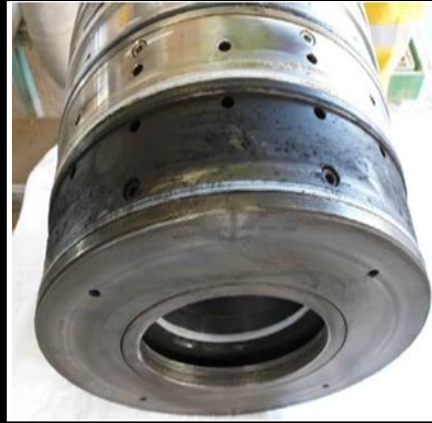
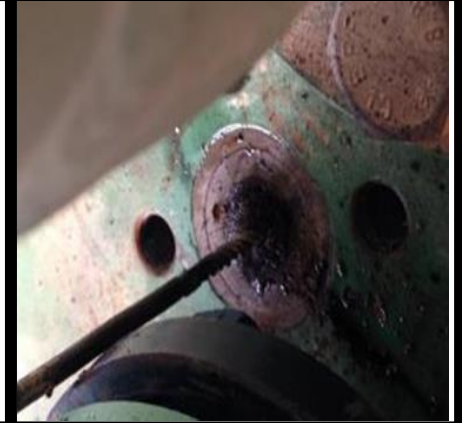
5.Very dirty Primary seal.

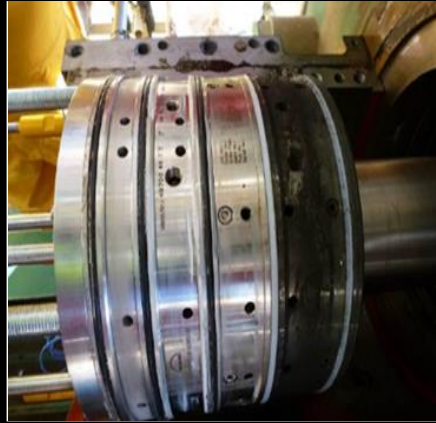
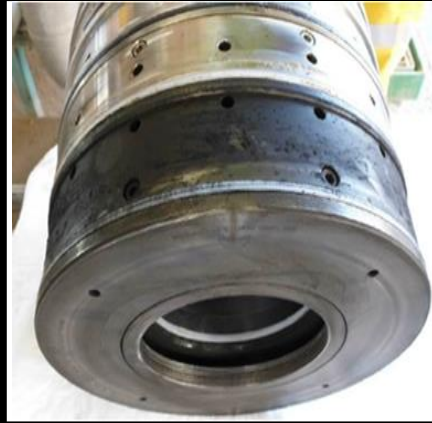
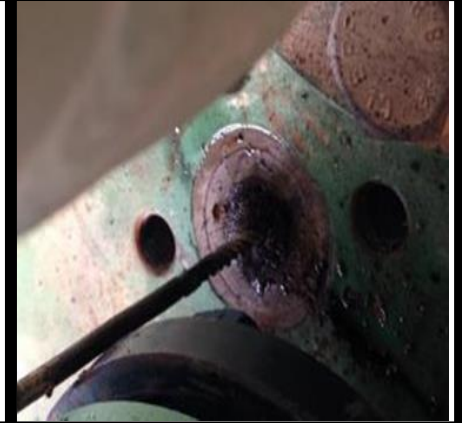
6.Contaminated DGS casing.

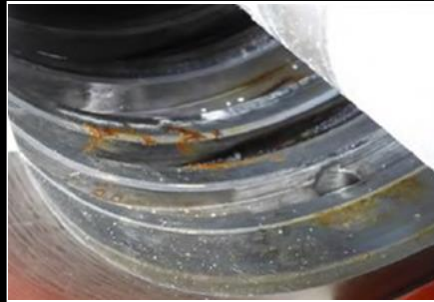
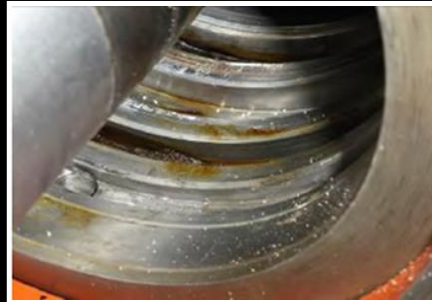
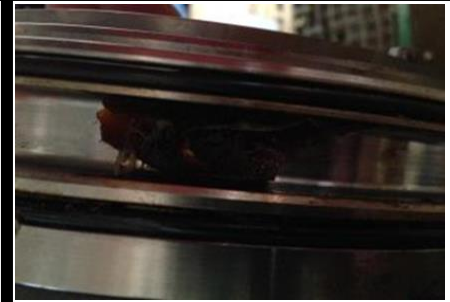
7. Condensate deposits inside the seal casing and outside the DGS cartridge.

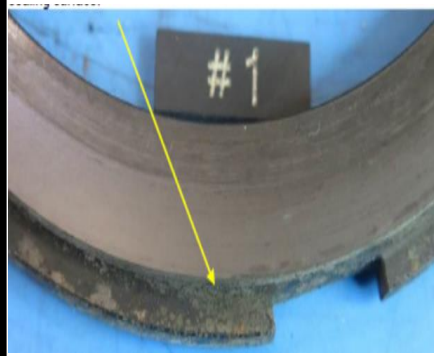
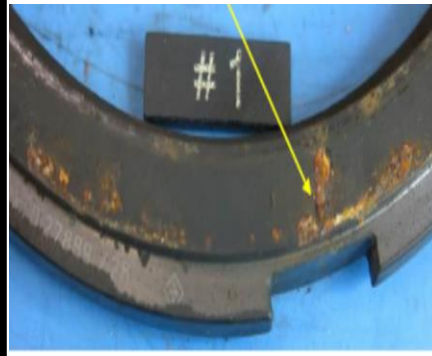
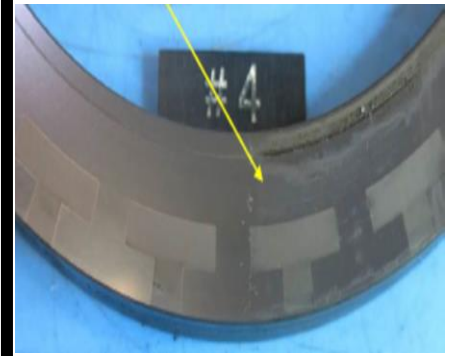
8. Seal Ring (#1) and Mating Ring (#4) from primary seal - Contaminated with rust like substance and liquid and contact traces on the sealing surface.

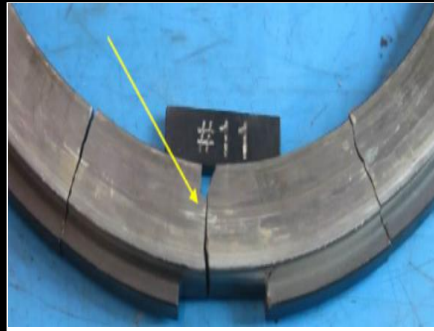
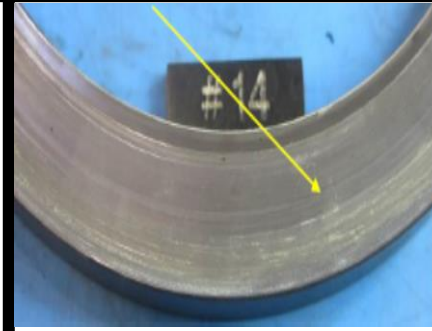
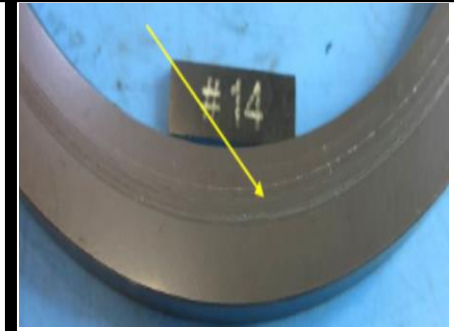
9. Seal Ring (#11) and Mating Ring (#44) from secondary seal

Heavy contract traces on the sealing surface and seal face broken in several parts

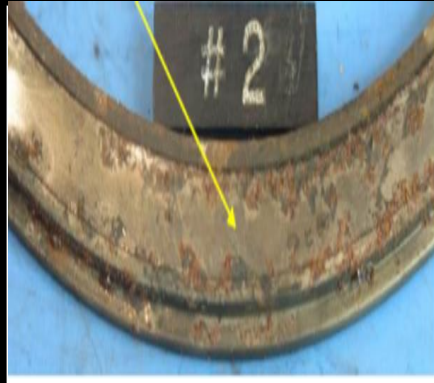
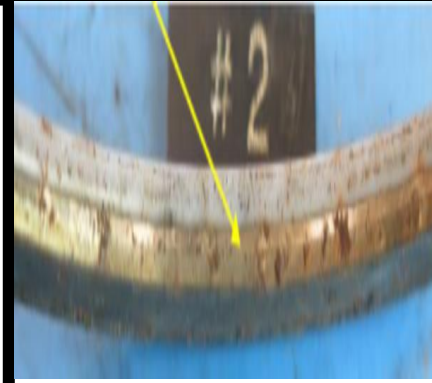
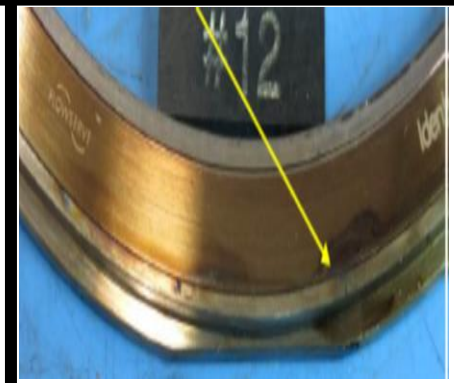
10. Seal element (#2) from primary sealing and seal element (#12) from secondary sealing -

Heavily contaminated with rust like substance and liquid. Pitting marks on the surface.

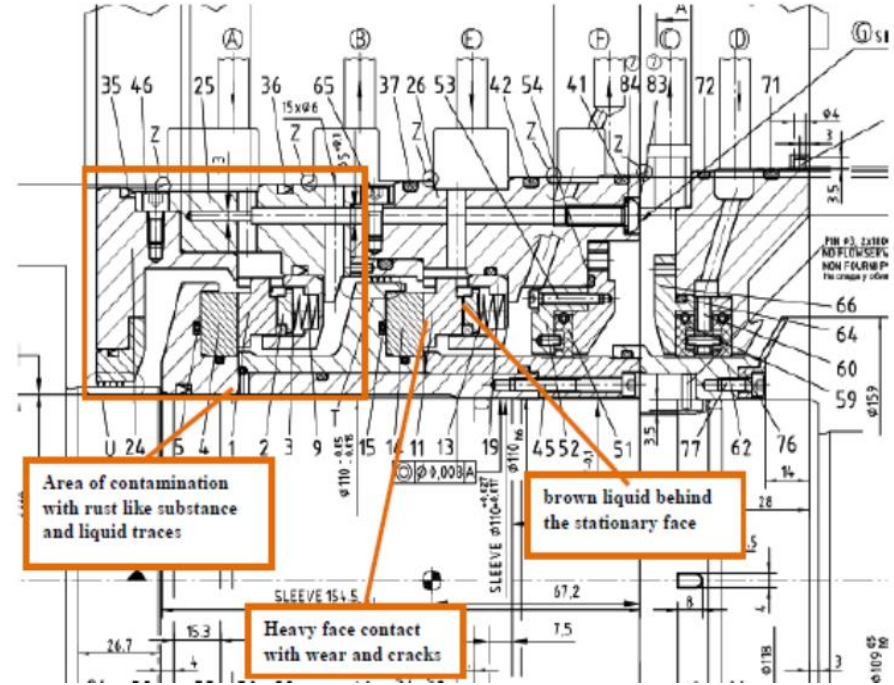
- Heavy face contact with wear on the rotating face sealing surface of the Secondary Seal.
- Presence of liquid dusty substance in the secondary seal gap that caused the face contact.
- Heavy contamination with rust like particles and traces of liquid in the Primary Seal/Process side.
